NASA/CR-2017-219668

# Hybrid Wing Body Multi-Bay Test Article Analysis and Assembly Final Report

*Alexander Velicki, Krishna Hoffman, Kim A. Linton, Jaime Baraja,  
Hsi-Yung T. Wu and Patrick Thrash  
The Boeing Company, Huntington Beach, California*

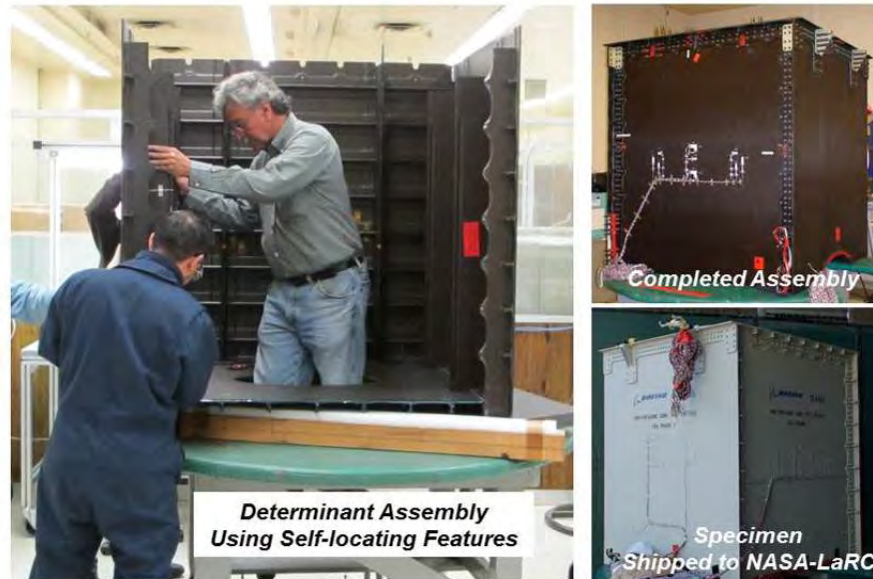
As the fundamental design aspects of the panel were coalescing, the focus of research shifted to another high-risk area of the HWB cabin design, the square corners along the edges of the pressure vessel. To better understand how the large integral PRSEUS panels could be efficiently joined in the corners to avoid adding excessive weight to the design, the cube risk-reduction test specimen pictured in Figure 2-9 was tested. The pressure-tight test article was to be tested to destruction in the COLTS facility to validate the edge and corner joint designs that would ultimately be used to design the larger MBB. Cube specimen buildup and completion are shown in Figure 2-9 (prior to testing).

**Figure 2-9. Cube Test Article Used to Validate MBB Design Approach**

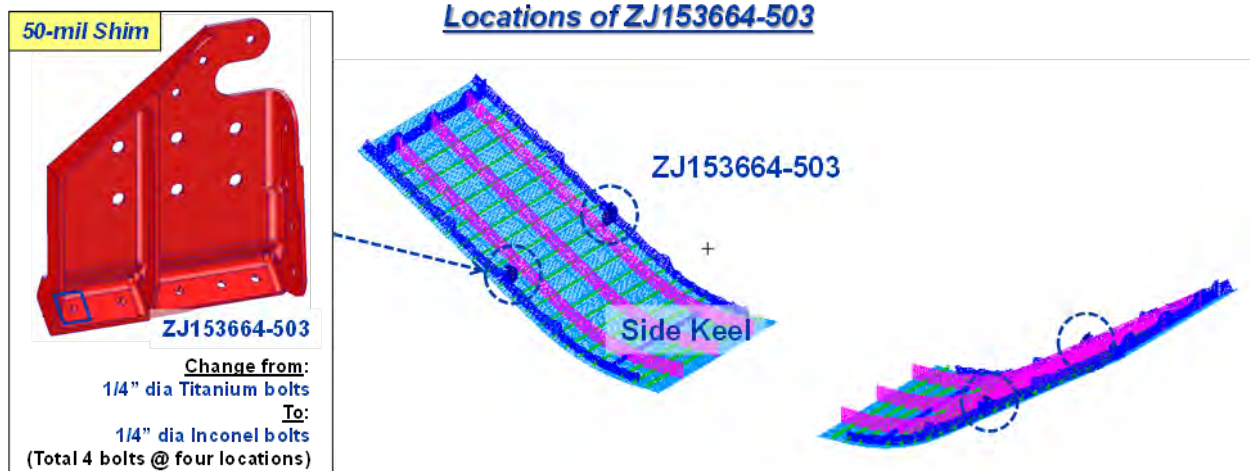
Figure 4-64. Fastener Change on ZJ153664-503 From the Fastener Bending Calculation

On the Bulkhead Frame Splice Fitting (ZJ153662-1), as shown in Figure 4-60, a fastener material change was needed on one of the bolts. In addition, on the other Bulkhead Frame Splice Fittings (ZJ153662-1/-501/-503/-505), as shown in Figure 4-61, some bolts did not require any design change, some bolts required a fastener material change, some bolts required a bigger fastener diameter, and some bolts required both material and diameter changes. On the Bulkhead Frame Splice to Crown Panel Fitting (ZJ153660-1) and the External Crown Stringer Support Fitting (ZJ153666-501), as shown in Figure 4-62, some bolts required a fastener material change and some bolts required both material and diameter changes. The same was true on the Bulkhead Frame to Floor Cap Clip Fitting (ZJ153903-1), as shown in Figure 4-63. On the Bulkhead Frame to Side Keel Canted Stringer Fitting (ZJ153664-503), as shown in Figure 4-64, a fastener material change was needed on one of the bolts. On the Bulkhead Frame to Center Keel Stringer Fitting (ZJ153664-511), as shown in Figure 4-65, a fastener material change was needed on one of the bolts. On the Lower Test Adaptor Box Fitting (ZJ153344-1) and the Lower External Side

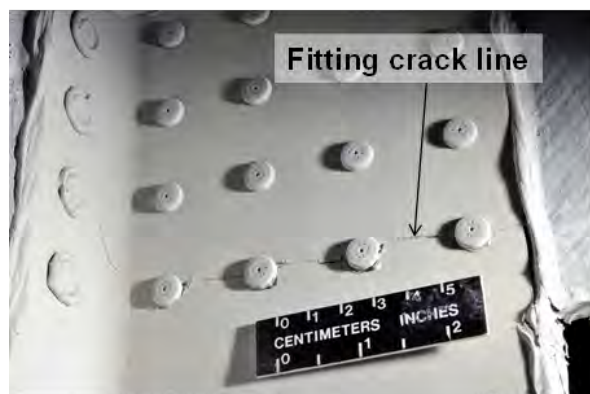
### Post-Failure Photo of Fitting

### Fitting Stress Analysis

**Figure 4-93. Pressure Cube Fitting Post-Failure Photograph and Predictions**

As shown in Figure 4-93 and Figure 4-94, this metallic fitting has 16 bolts fastened to the frame on the crown and 8 bolts fastened to the frame on the rib. The behavior of the frames at these fastener locations in the pressure cube test provided useful information regarding the

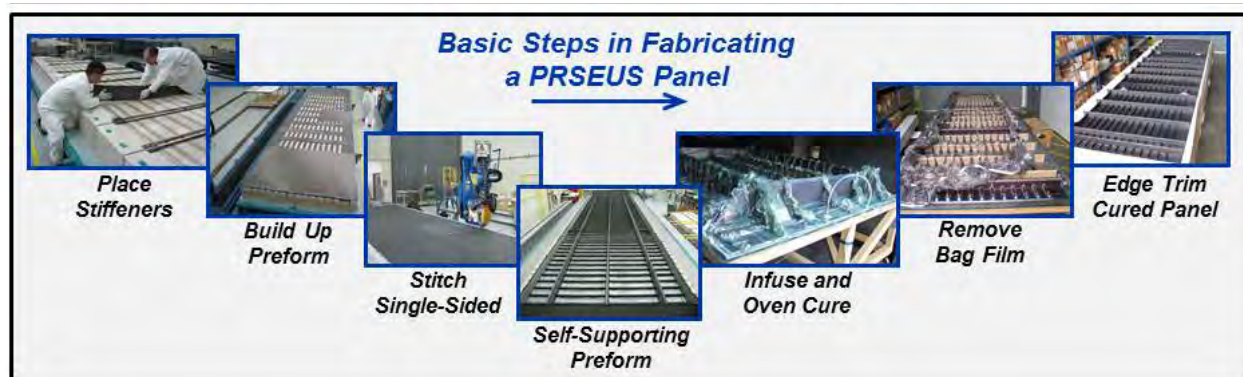
**Figure 5-1. Preform Assembly and Cure Tooling Are Primary Toolsets for Panel Fabrication**

Two primary toolsets were used to construct the PRSEUS panels. First, a stitching fixture was used to hold the dry fabric in position during the stitching operation, and then a rigid mold tool was used to support the dry stitched preform during the resin-infusion and cure operations. Key steps in building a PRSEUS panel are shown in Figure 5-1. The photographs on the left side of the figure show the preform assembly and stitching steps, and the photographs on the right show the key resin-infusion and cure tool steps.

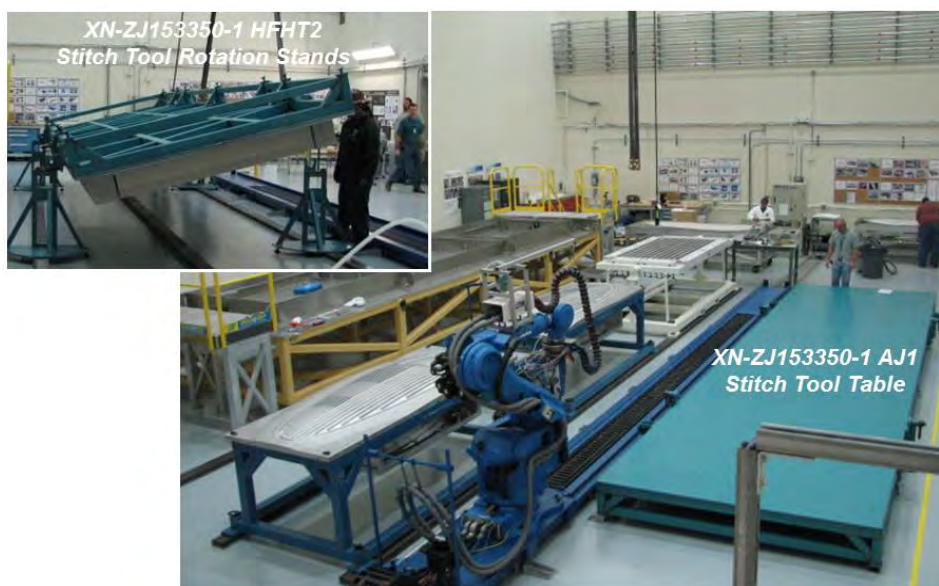
**Figure 5-3. Common Stitching Table Used to Support Different Foam Block Configurations**

The preform assembly fixture, or stitching tool, consisted of two main elements: (1) a common support table with a series of precision-drilled holes that were used for indexing the foam blocks, and (2) the actual sets of foam blocks that support, shape, and locate the dry fabric details that hold the skin, stringers, frames, and cap elements for the preform stitching operations. The common support table (Figure 5-3) was a conventional welded steel construction with indexing features positioned at the corners. This enabled the table to be accurately repositioned relative to the stitching head rail system each time it was moved to deliver the preform to the cure tool. Additionally, the table was relatively rigid to limit deflections during the preform rotation step (pictured in the upper left corner of Figure 5-3) to ensure that the preform did not deform or change position as it was being lowered onto the cure tool. Table design and fabrication were straightforward exercises, despite some minor rework required to increase the table bending stiffness. (The only major challenge was to ensure that the numerous locating holes through the flat surface would not interfere with one another for each different panel configuration.)

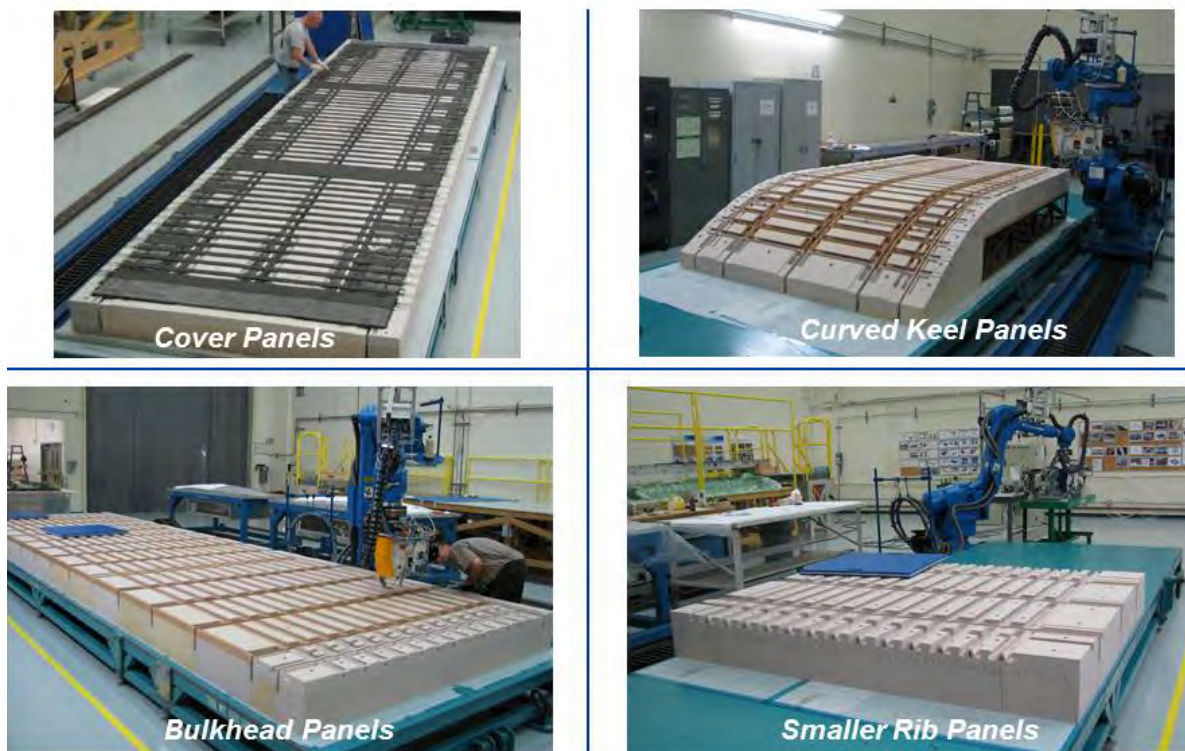
**Figure 5-8. Multiple Block Configurations Shown on Common Stitching Table**

This basic tooling arrangement was repeated six times for each of the unique PRSEUS panel configurations (not counting left-hand and right-hand panels twice). Compared to the initial crown panel design, the differences for subsequent tools (Figure 8) primarily involved changes to frame and stringer orientations, as well as the addition of the curved segment on the outboard keel panels. All of these changes were planned from the beginning to be accommodated by the reconfigured sets of foam blocks indexed to the common hole pattern drilled in the support table. In general, this approach worked well and accomplished its primary objective of reducing the upfront tooling acquisition costs. The only negative aspect of this approach was that the sharing of common tooling details undeniably limited the flexibility to uncover tool design problems during setup. This was because it forced each toolset to be inspected sequentially rather than in a more efficient parallel manner.

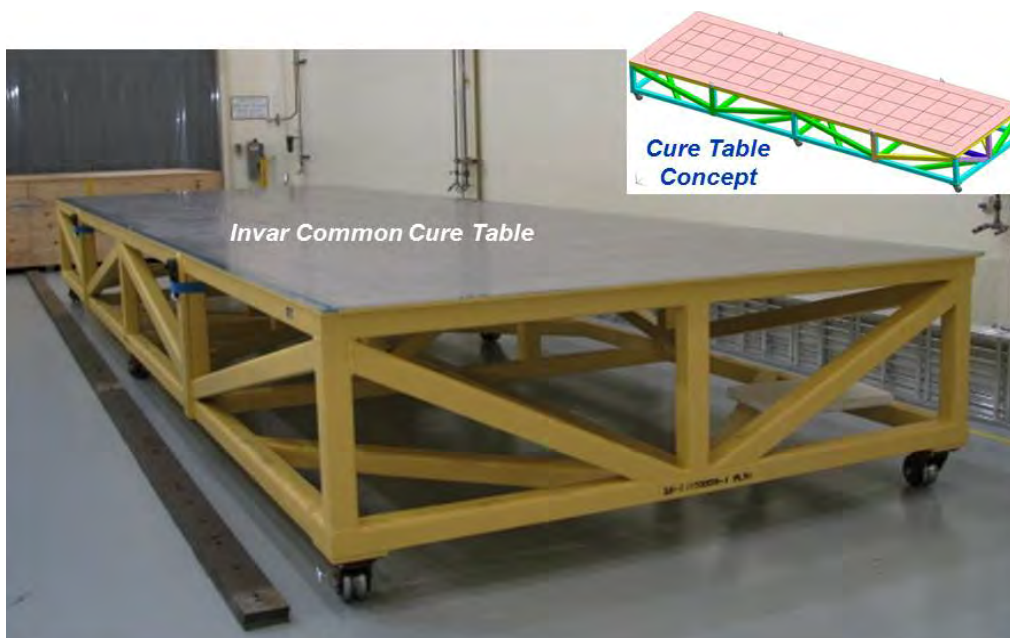
**Figure 5-9. Common Cure Table Used to Support Different IML Tooling Arrangements**

The common cure table (Figure 5-9) was fabricated by a local tooling vendor using a conventional welded Invar steel construction approach. The table consisted of a nominal 0.50-in.-thick plate supported by a rolling 4- by 4-in.-square tube-welded support structure. A shallow grid system was machined into the plate surface to deliver resin to the preform OML, which would be fed by a collection of disposable Teflon lines and brass quick-disconnect valves that were secured to the edges as well as underneath the table.

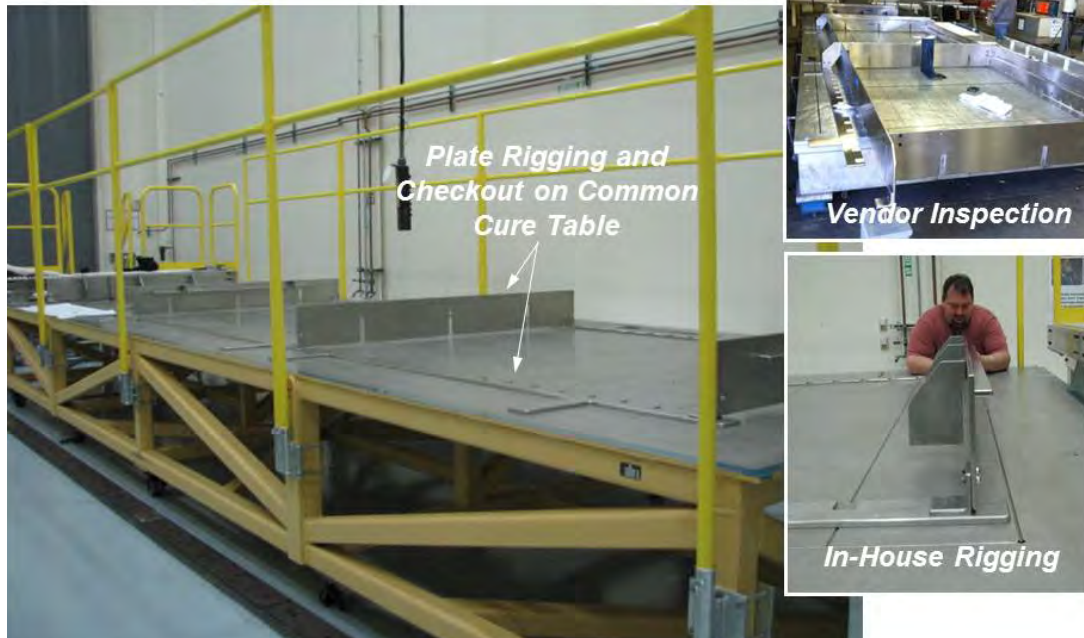
**Figure 5-10. IML Details Rigged and Checked Out on Common Cure Table**

The dimensionally critical features of the panels were molded by under-bag tooling details that were indexed to the common hole pattern drilled into the cure table surface (Figure 5-10). Although this same basic tooling approach was used successfully to build the 4-ft-long cube specimen panels, the scale-up to 30-ft-long panels was expected to be challenging. Those concerns were quickly realized during the plate rigging and inspection signoff on the first cure tool at the vendor's site. During the dimensional checks, it was evident that the large end-supported plate members were sagging and bowing out-of-plane due to their mass, which had not occurred on the smaller cure tools. To resolve this problem, the end supports were changed and a stiffener member (as shown in the lower right photograph in Figure 5-10) was added to each of the longer plate members. These changes resolved the problems, and the tools could then be assembled to meet the stringent dimensional tolerances required for the rib station plane surfaces that would be molded by the plates.

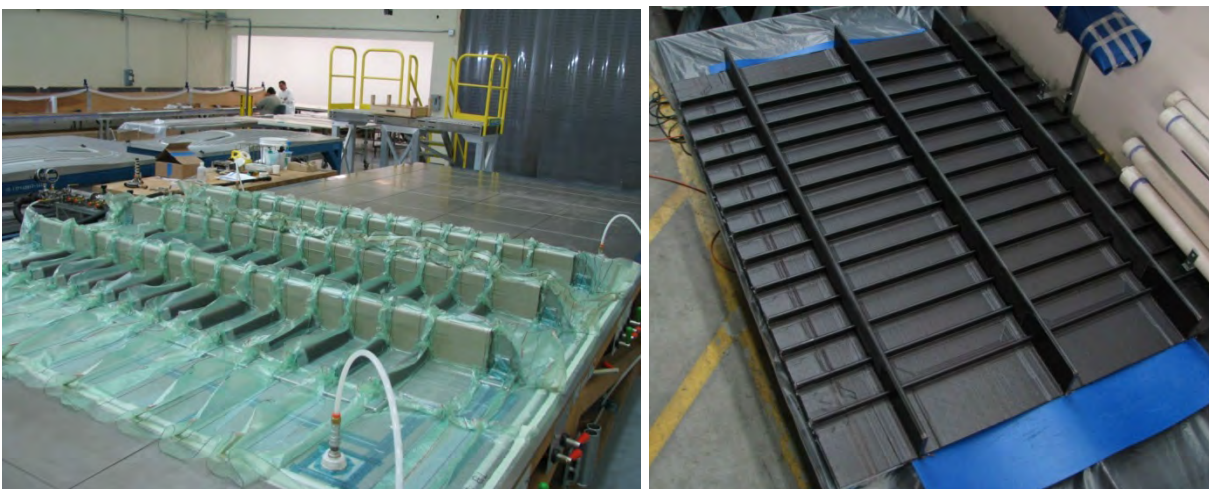
**Figure 5-14. Rib Panel Shown Under Vacuum Before Infusion and After Cure**

Figure 5-14 shows the pleated vacuum bag placed over the rib panel tools on the left, and the completed panel is shown on the right after resin infusion and cure. Although under-bag tooling seems to be relatively complex, the capability to remove a near-finished, fastener-less, and integrally stiffened panel geometry from the oven justified the added investment in tooling and panel preparation to eliminate downstream drill-and-fill operations, which are typical of conventionally built-up panel constructions.

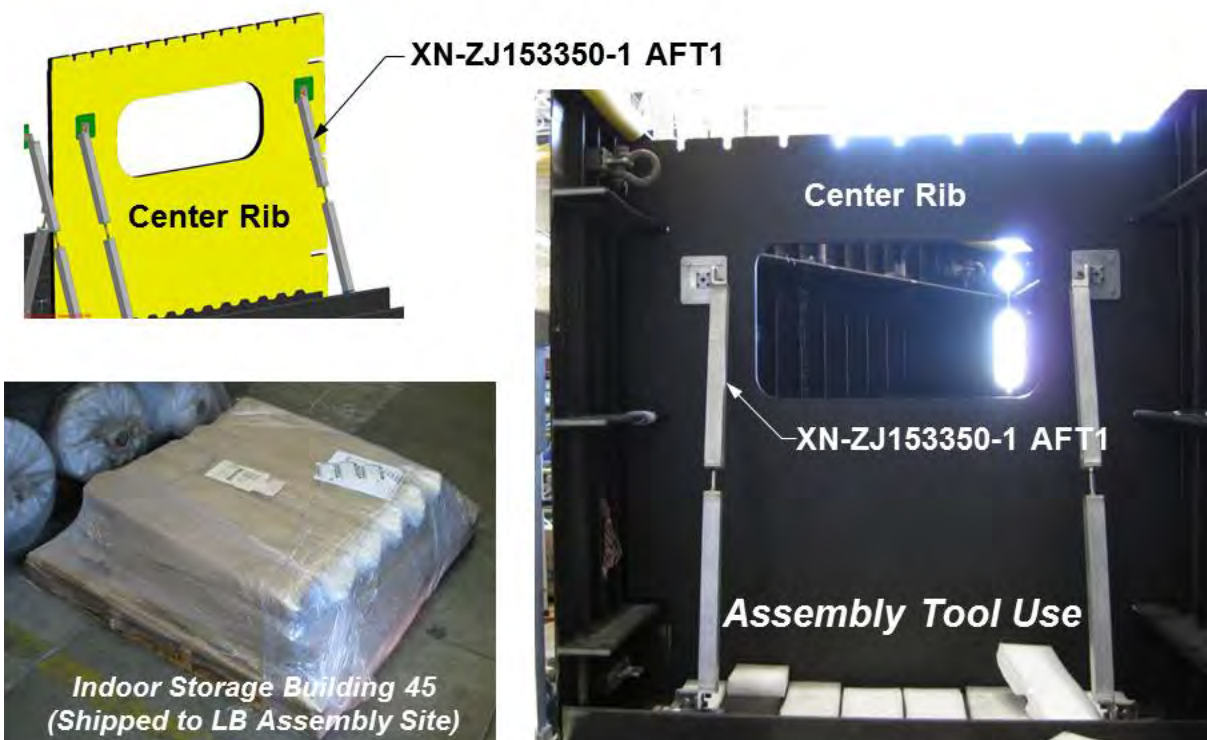
**Figure 5-17. Holding Aids Used to Support Internal Ribs During Assembly**

Smaller ancillary toolsets were also required to support panel assembly operations. Adjustable struts (Figure 5-17) were fabricated to help position rib members, a multi-element floor-protection system (Figure 5-18) was used to provide protection from tool drops and foot traffic during assembly, and a lift-beam assembly (Figure 5-19) was designed that could move anything from an individual panel to the entire completed MBB.

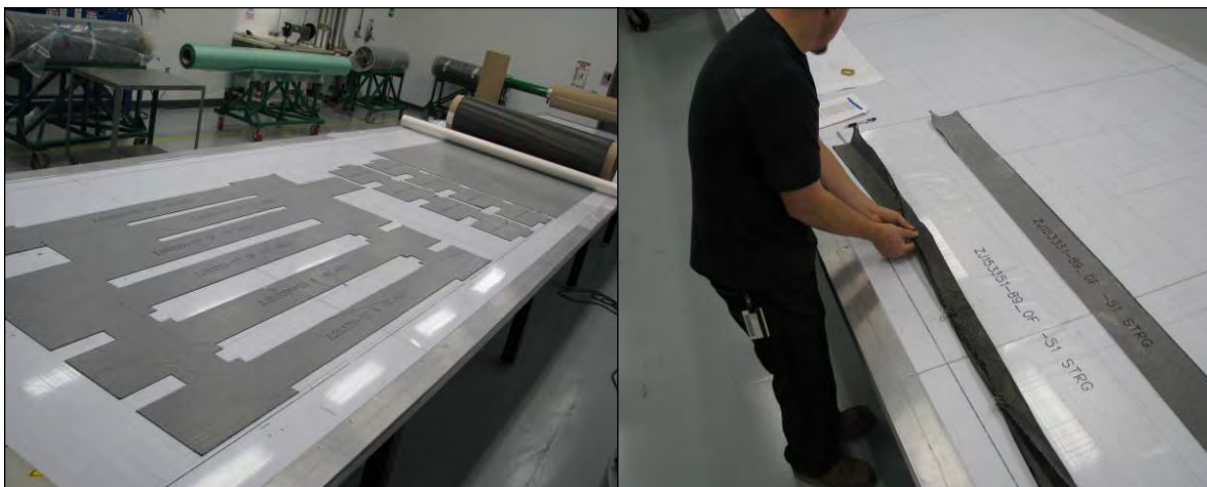
**Figure 6-4. Stringer Nested Flat Patterns and Folding of Stringer Ply Stacks**

The PRSEUS design utilized a bulb-shaped stringer cross-section with a varying flange width and localized buildups dependent on stringer location on the panel. Stringer preforms were fabricated using 55-in.-wide carbon-fiber multi-axial warp-knit fabric of a seven-layer construction and having a total fiber areal weight of 1,425 gsm. Net-sized flat patterns were created and nested to optimize material utilization. A Computer Numerically Controlled (CNC) ply-cutting table was used to cut the flat patterns from the wide fabric, as shown in Figure 6-4. Base stack material along with doubler plies were laid out flat onto a table surface. The doubler plies were secured to the base stack material using tack stitches inserted by hand. A stainless-steel twisted wire cable was placed down the centerline of the layup. The flat layup was then folded over upon itself along the centerline to capture the cable. The cable facilitated the installation of the pultruded rods to form the bulb feature of the stringer during final assembly of the entire panel preform.

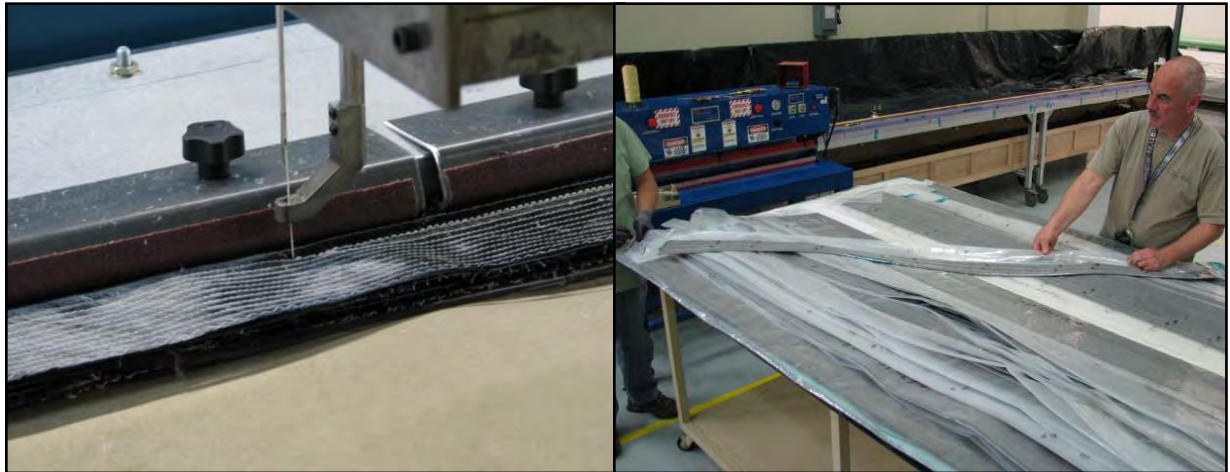
**Figure 6-5. Stitching of Stringer Preform Web Shown With Vacuum-Bagged Stringer Preforms**

Binder clips secured the folded material assembly as it was positioned by hand inside a holding jig. As shown in Figure 6-5, the jig was located inside a gantry-type stitching machine, wherein seams of stitching were inserted into the web of the stringer. A lock stitch was used with 1,200-denier Vectran sewing thread to meet engineering strength requirements. A single seam of stitching was inserted near the fold line to create the bulb feature of the stringer. A second seam was installed at the tangent point for the web-to-flange radius. With the bulb feature still in the collapsed position and the flanges yet to be formed, the stitched stringer preform was then placed inside a sealed polyethylene vacuum bag and forwarded to the panel preform assembly jig.

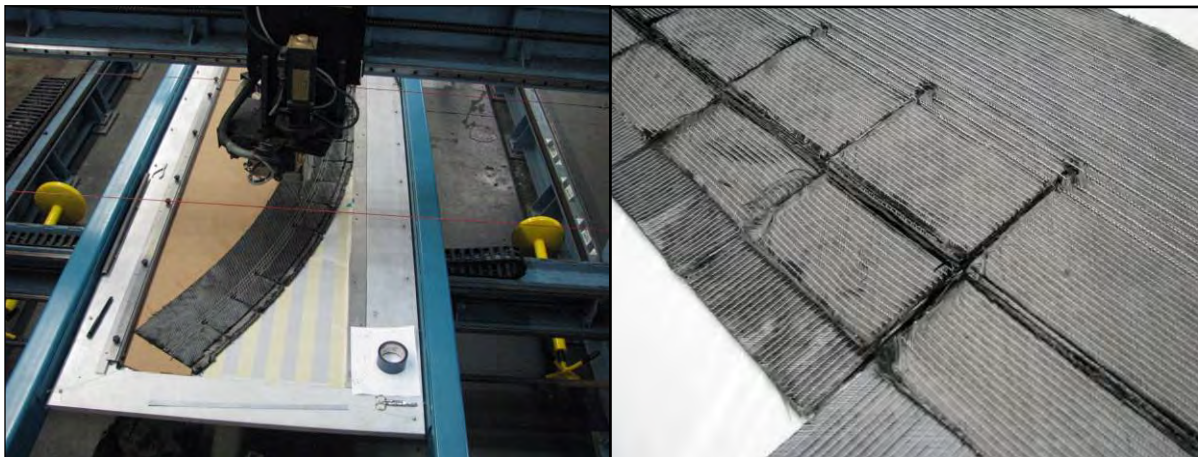
**Figure 6-6. Stitching of Bulkhead Cap Preform Shown With Net-Size Features**

Structural panels for the MBB contained integrated rib and bulkhead cap elements of a “T” type cross-section (referred to as T-caps), with the flat web section oriented according to the mating rib or bulkhead panel direction. Bulkhead and rib cap preforms were fabricated using a similar approach to that used for the stringer preforms. One exception was that the NCF ply stacks for the cap were not folded over but rather laid up and stitched in the flat condition, as shown in Figure 6-6. As was the case with the stringer preforms, the flat patterns for the cap plies were cut on a CNC ply-cutting table to net size (i.e., no manufacturing trim), and they included stringer keyhole features. The web feature of the cap received multiple parallel rows of stitching over the entire surface, bound at the bottom by the tangent point of the web-to-flange radius. As shown in Figure 6-7, ply stacks for the flanges were typically extended at discrete locations for interleaving with the adjacent frame and/or cap flange ply stacks during final assembly of the entire panel preform.

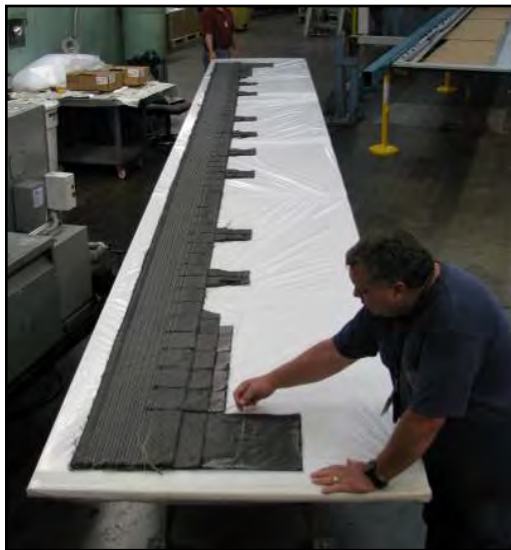
**Figure 6-7. Complete Bulkhead Cap Preform for Crown Panel With Extended Flange Stacks**

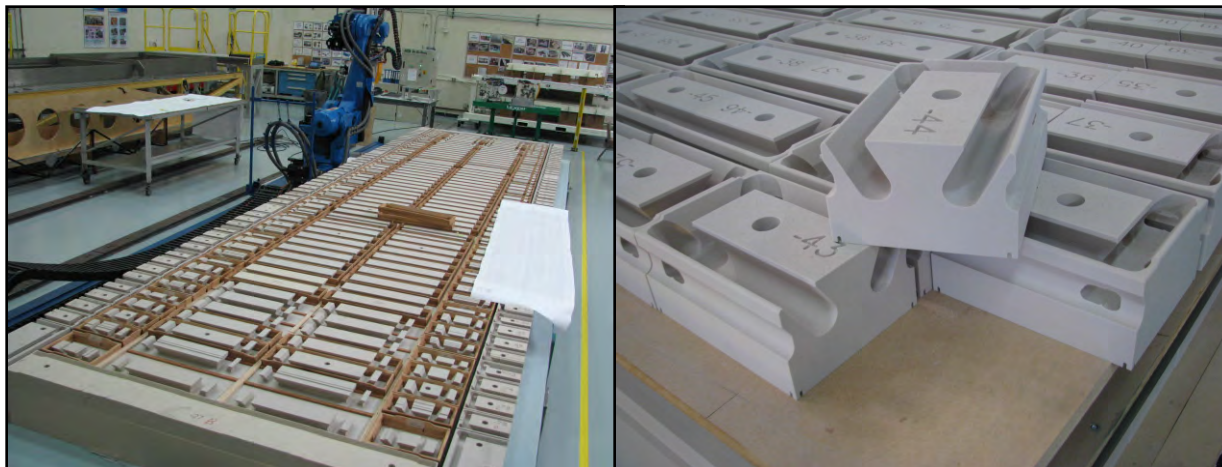
**Figure 6-9. Preform Assembly Jig for Crown Panel Utilized Machined Foam IML Tool Blocks**

A jig was used for assembling the stringer, frame, cap, and skin components into a complete near-net-shaped 3D preform for each panel. The jig consisted of Inner Mold Line (IML) tooling details pinned and bolted to a welded steel base platform that was located in the robotic stitching cell (shown in Figure 6-9). CNC-machined, 10-lb/ft<sup>3</sup> urethane foam blocks and small wooden “picture-frame” components supported and positioned the separate frame, cap, stringer, and skin details relative to one another. Cavities incorporated into the design of the IML tool enabled one-sided stitching of stringer, frame, and cap flanges to the base skin. The sewing needles penetrated through the thickness of the preform and exited the bottom surface of the material into the tool channel, where the sewing thread loop was formed and subsequently captured by the hook on the catcher needle. The foam blocks and wood picture frames were wrapped with a lightweight fiberglass cloth to support the soft carbon fabric during installation of the flange-to-skin seams of stitching. On subsequent panels, the jig was sized to accommodate the accumulative bulk of the preform with respect to the stitching plane. The wood stitching frames were incorporated into the design of the jig as a cost-reduction measure. It was originally believed that using wood frames would take less effort to design, fabricate, and use than would fully machined foam blocks; however, that assumption was incorrect. Future preform assembly jig designs will use the fully machined foam blocks exclusively (Figure 6-9).

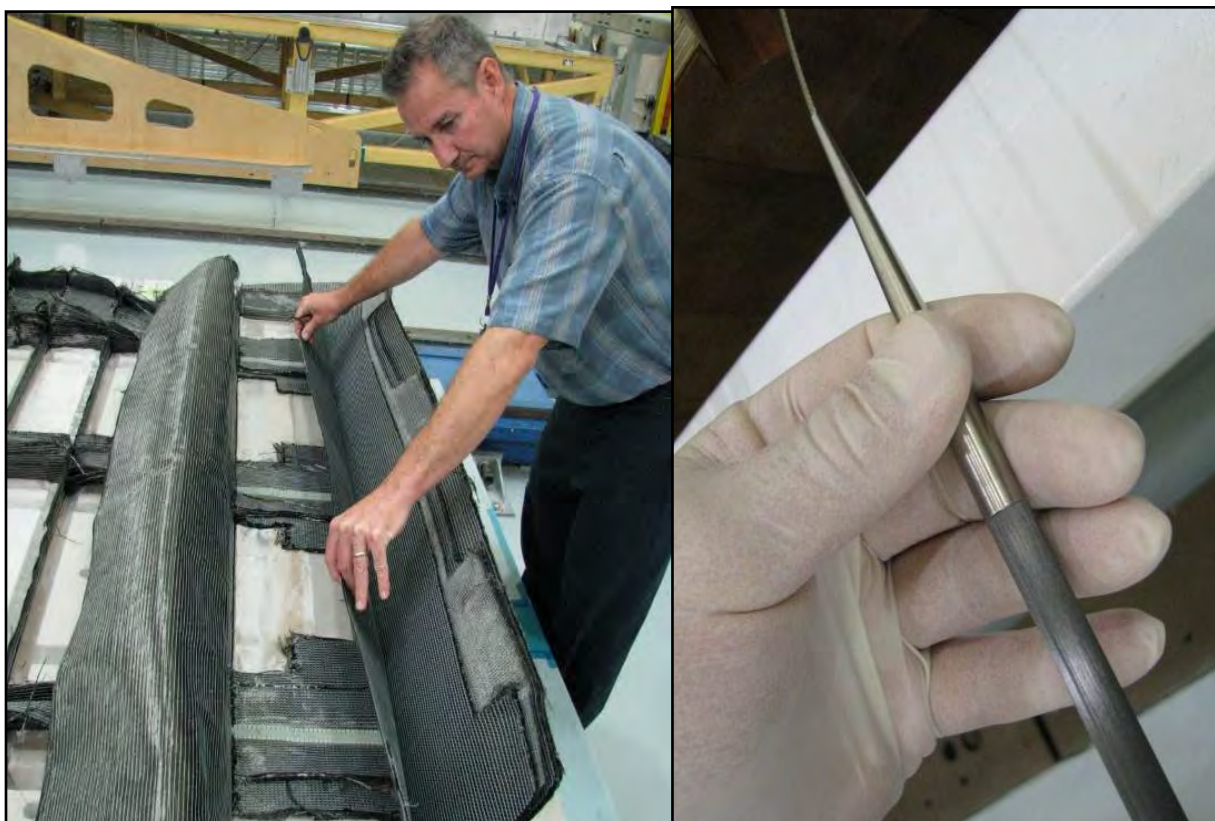
**Figure 6-11. Forming of Cap and Frame Flanges (left), Carbon Rod With Leader Wire Adapter (right)**

The pultruded rod was then attached to the end of the twisted steel wire cable located inside the top of the stringer web using a specially designed adapter (Figure 6-11). Next, the rod was installed into the stringer by pulling on the steel cable and pushing on the rod. This subsequently formed the bulb feature of the stringer and locked the stringer into the frame foam core as the rod passed through the preform. The stringer flanges were then folded down against the tool and 3D woven fillets were installed at the base of the stringer web, as shown in Figure 6-12. Tear straps were laid up over the formed flanges of the frame and stringers. Skin ply stacks were then laid up over the tear straps and cap flanges (Figure 6-12.)

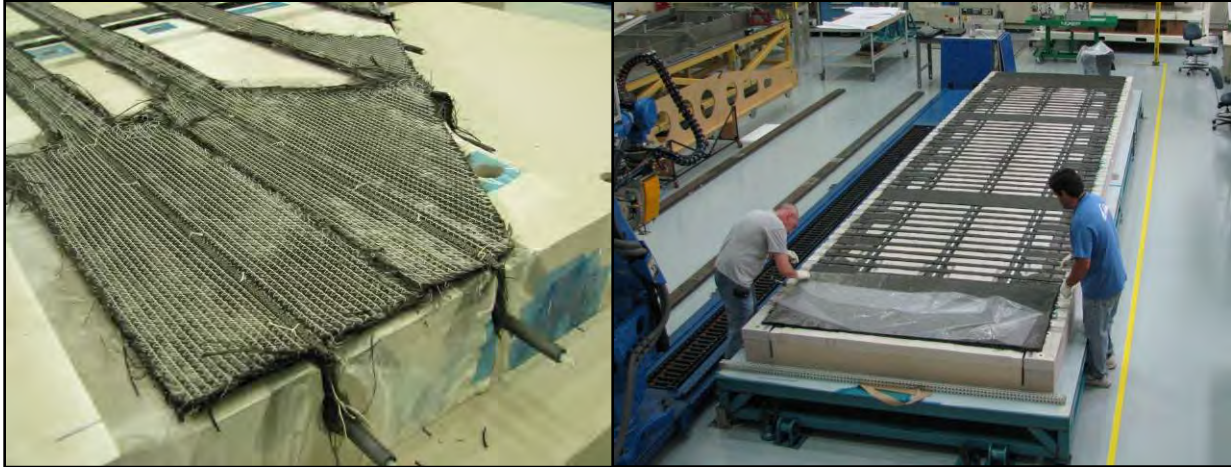
**Figure 6-12. Rod and Fillet Installation (left) and Skin Layup Under Progress (right)**

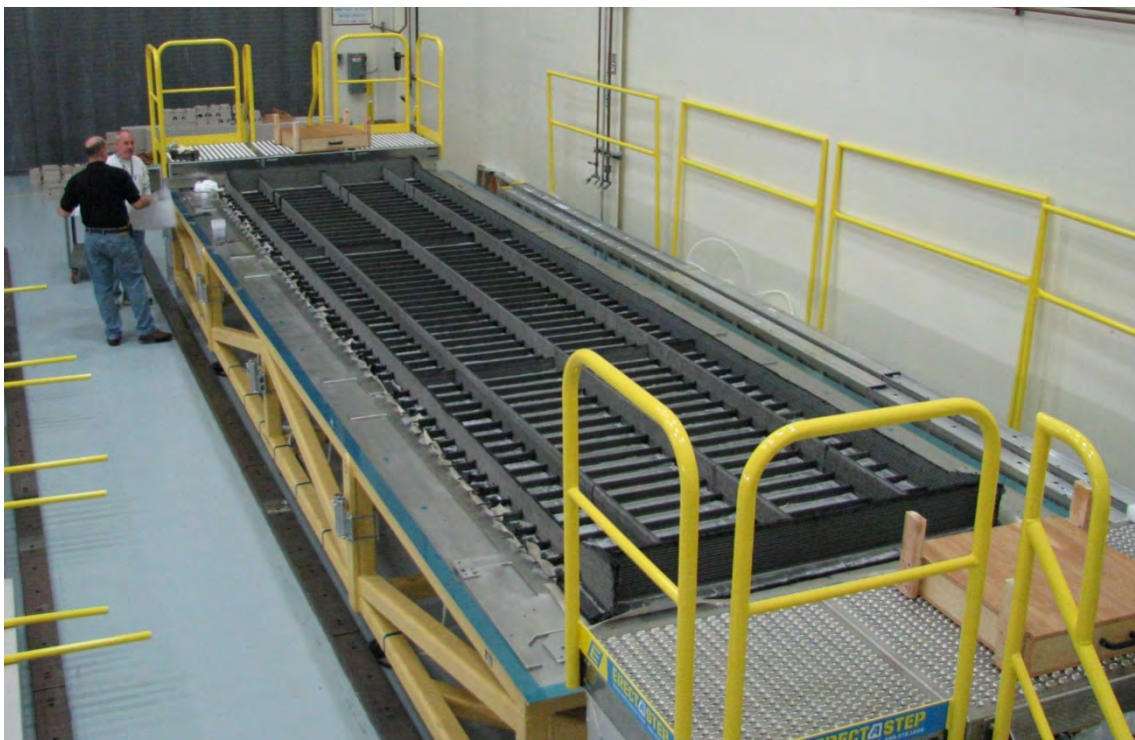
**Figure 6-16. Crown Panel Preform Positioned on OML Tool**

Resin-infusion processing of the panel dry fiber preform assembly was accomplished using the Boeing CAPRI process. Tooling consisted of a one-piece welded OML tool and multiple IML tooling details constructed of Invar steel. Silicone rubber mandrels were used over the bulb stiffeners to aid in installation of the vacuum bag. The OML tool contained integral ports welded to the bottom surface of the tool facesheet for mounting resin inlet valves and vacuum outlet valves. Grooves machined into the top surface of the facesheet intersected with the inlet ports and facilitated distribution of the resin across the tool surface. Once the mold tool was cleaned and a release agent applied, flow media was then allocated over the mold surface followed by perforated plate and release ply layers. The preform was then transferred from the assembly jig to the mold tool. This was accomplished by first banding the preform down against the assembly jig. The entire assembly was then raised using an overhead crane and rotated so that the skin was facing down when placed over the mold tool (Figure 6-15). The banding straps were then removed from around the preform, and the assembly jig was removed, leaving the preform resting on the mold surface, as shown in Figure 6-16. The IML tooling details were installed over the preform followed by the installation of the primary and secondary nylon vacuum bags (Figure 6-17 and Figure 6-18). The mold tool with part was then moved inside a walk-in oven for resin-infusion processing and cure.

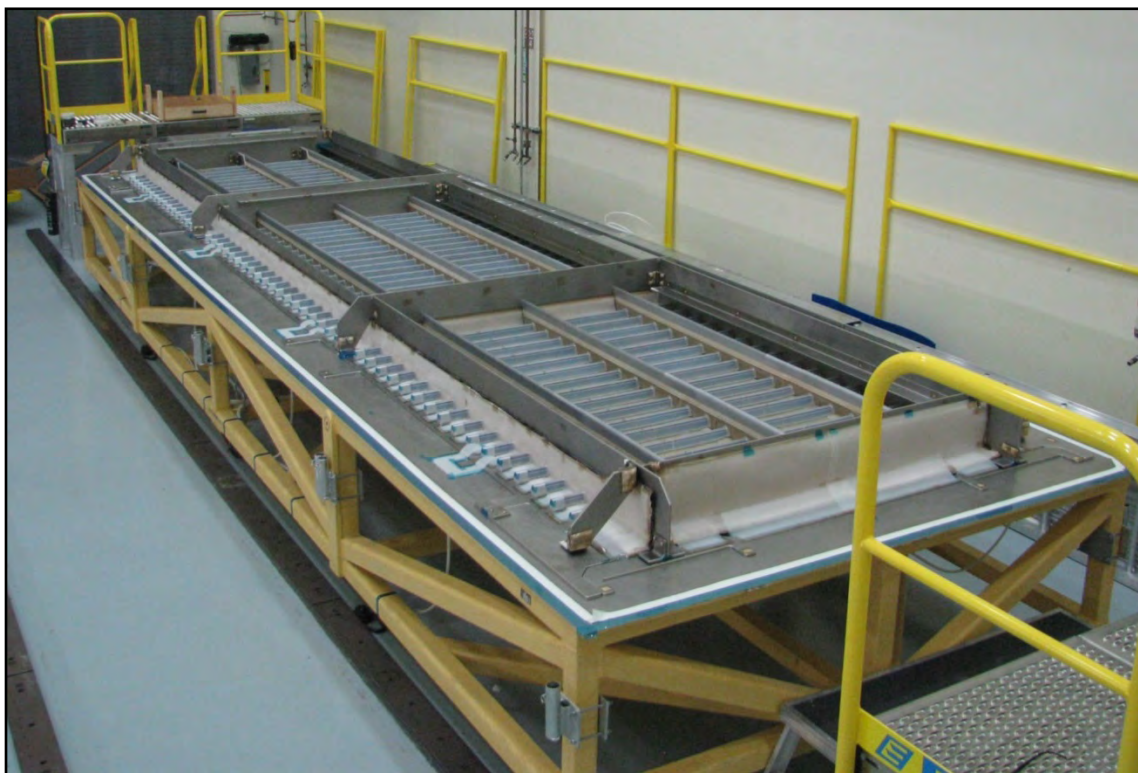
**Figure 6-17. Installation of IML Tooling Over Crown Panel Preform**

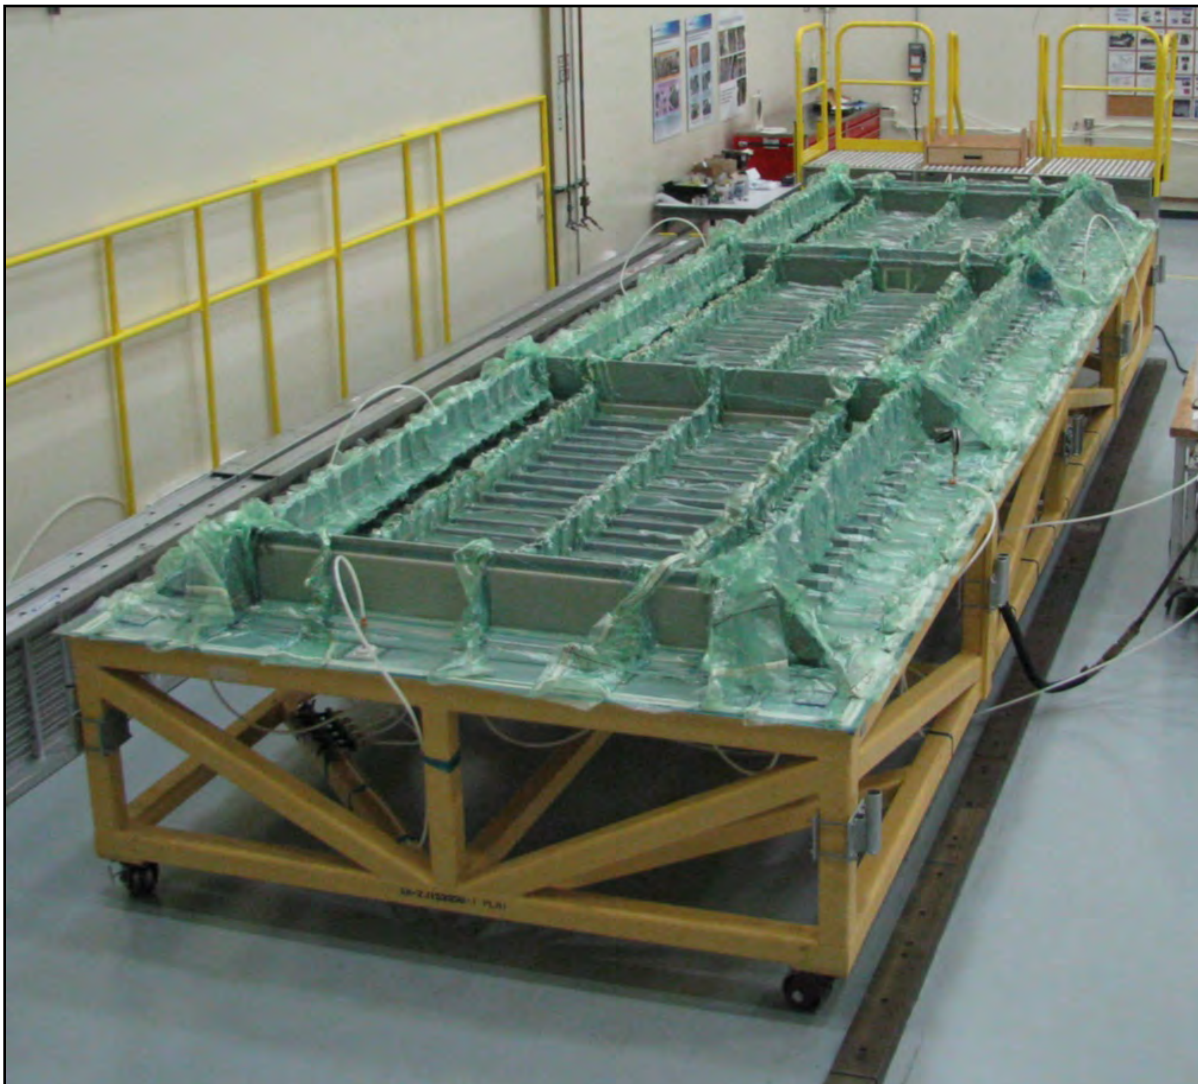
**Figure 6-18. Installation of Vacuum Bag Over Crown Panel Preform and IML Tooling**

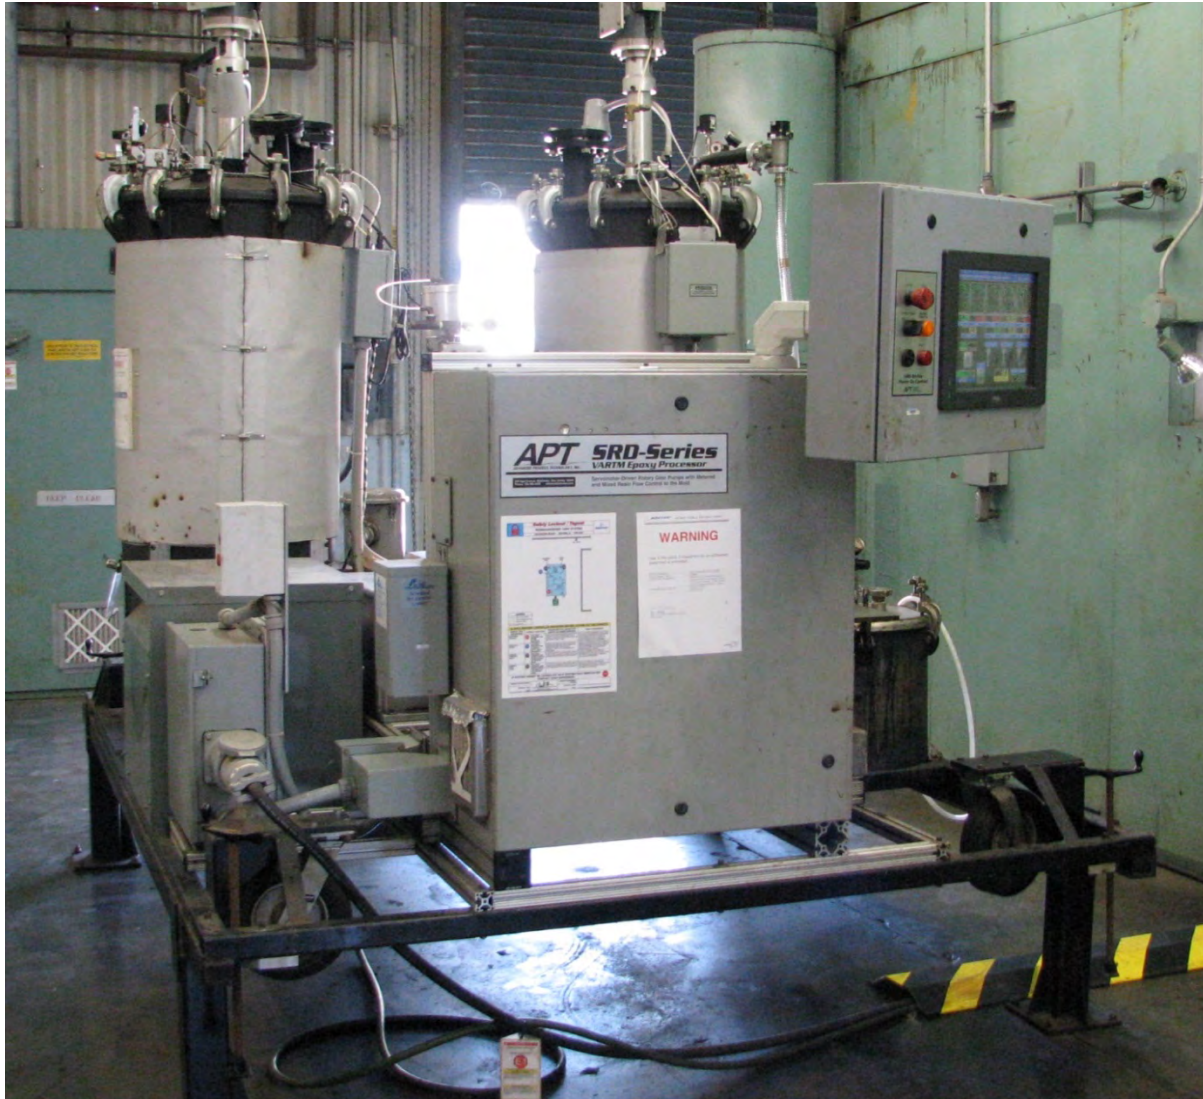
Figure 6-19. APT Servo Rotary Dispensing Machine for Automated Resin-Infusion Processing

A Servo Rotary Dispensing (SRD) machine (Figure 6-19), manufactured by Advanced Process Technology (APT), was used to prepare the epoxy resin and infuse the preform. Resin and hardener were loaded into the respective holding tanks on the machine and thin-film degassed at elevated temperature. A single mold line connected the machine to the resin inlet manifold on the mold tool. With the mold at temperature and materials properly degassed, the preform was infused in an automated manner using the SRD machine, which metered, mixed, and delivered the resin at a specified pressure on demand. Infusion of the 28-ft-long by 7-ft-wide highly integrated panel (as shown in Figure 6-20) was completed in approximately 45 min. Once resin-infusion processing of the panel preform was completed, the machine was stopped, the mold lines were disconnected, and the temperature of the oven was raised to 200°F to complete the initial part cure. The part was cooled to room temperature, the vacuum bag system removed, and the IML tooling taken off (Figure 6-21). The panel was then lifted off the OML tool to enable the flow media to be removed from the bottom surface. The part was placed back down onto the OML tool and post-cured at 350°F inside the oven. Figure 6-22 shows the as-cured crown panel before periphery machining.

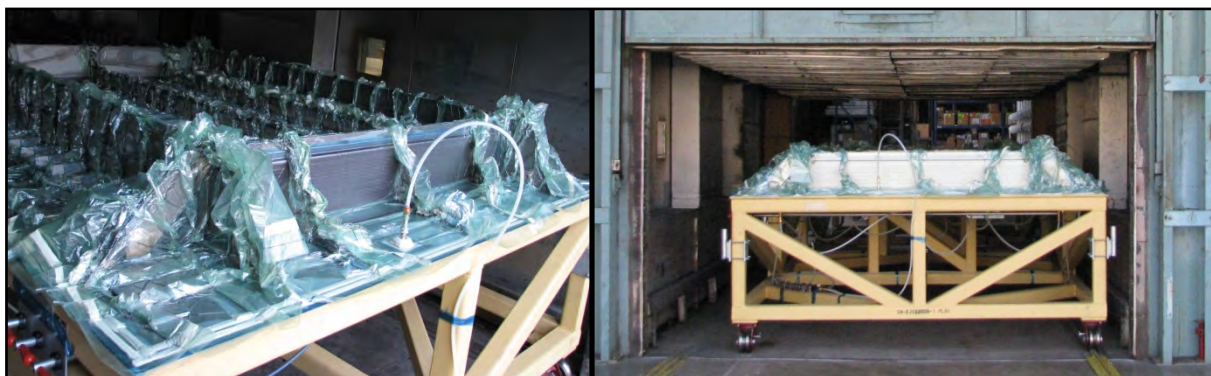
Figure 6-20. Resin-Infusion Processing of Crown Panel Inside Oven

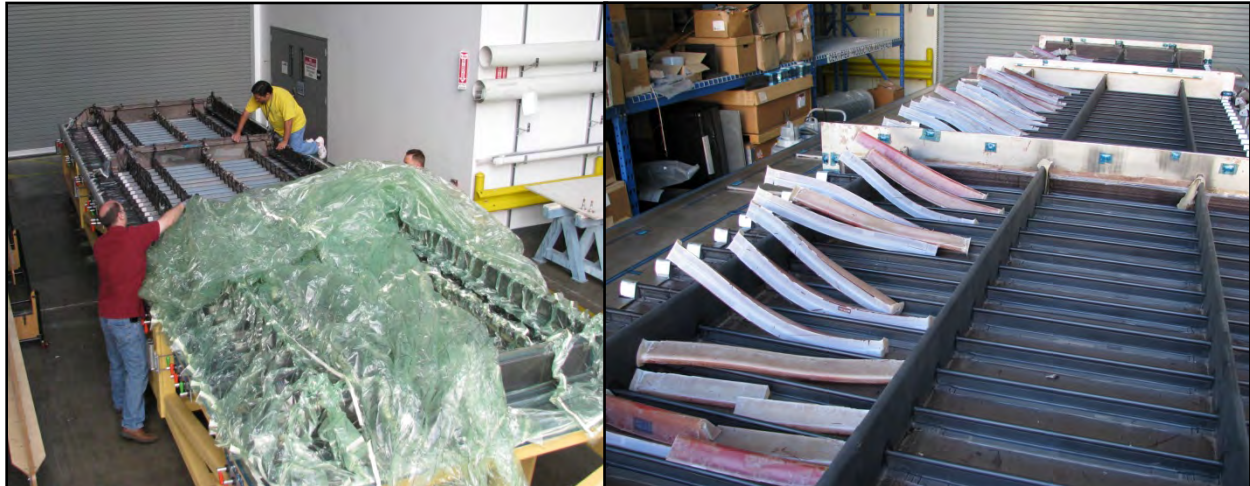
**Figure 6-21. Removal of Vacuum Bag and IML Tooling From Infused and Cured Panel**

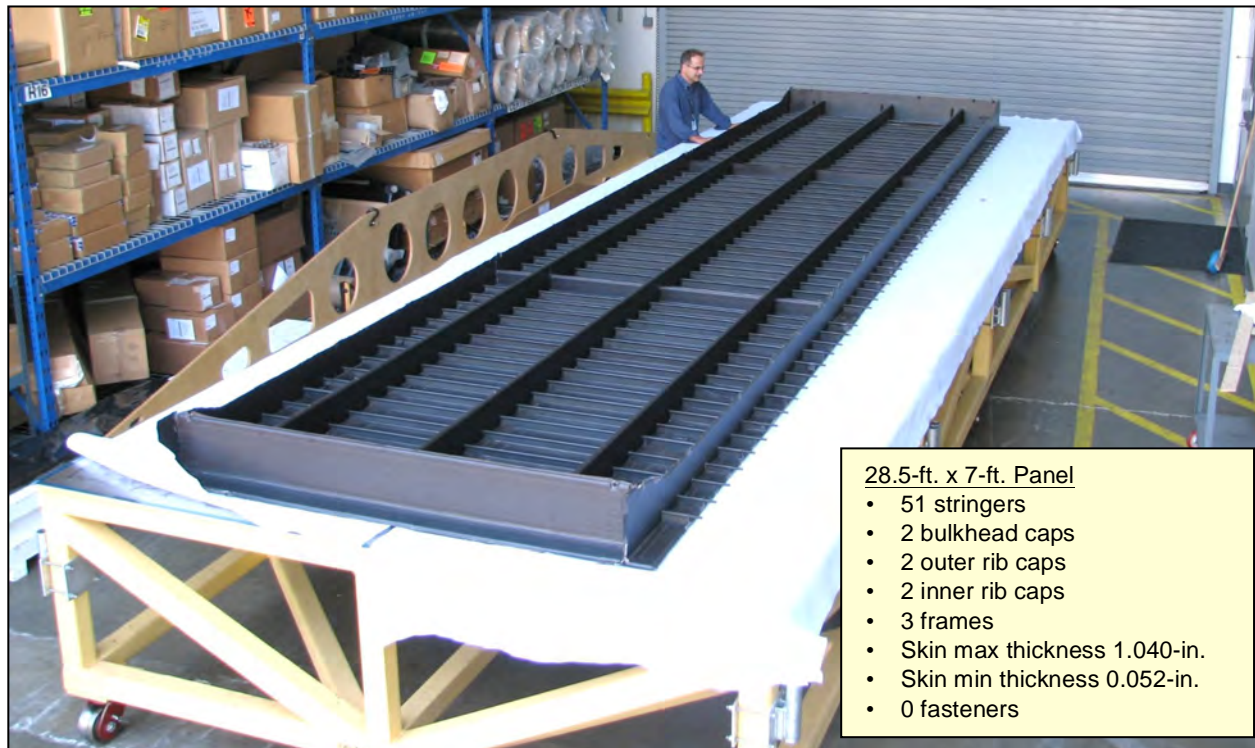
**Figure 6-22. Resin-Infused and Cured Crown Panel Before Periphery Machining**

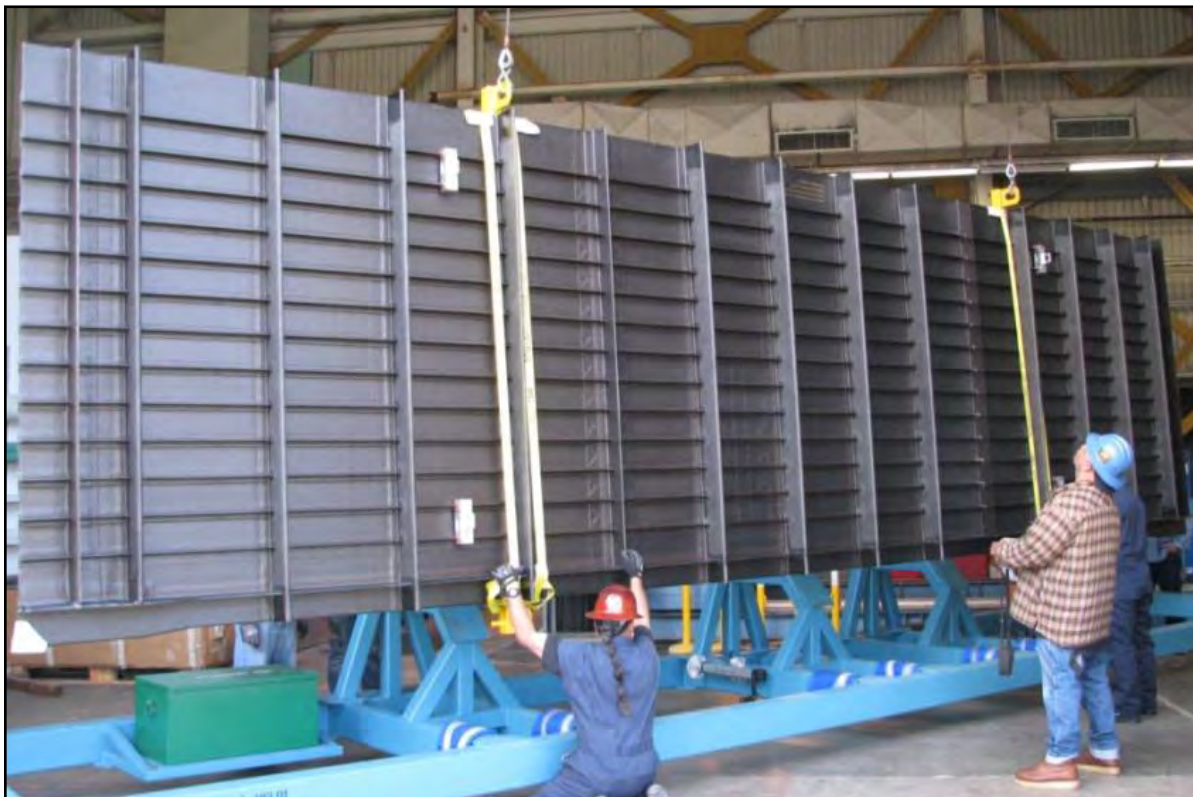
**Figure 6-29. Upper Bulkhead Panel Loaded Onto Transport Dolly for Shipment**

Panels were manufactured with excess material around the perimeter and along the top of the bulkhead/rib cap webs. The final profile of the skin and caps was achieved by machining at an outside supplier. To accomplish this, a cured panel was placed onto a large transport dolly (Figure 6-29), the dolly with panel was loaded inside a SEAVAN container (Figure 6-30), and the panel was then transported by truck to the machining supplier's facility.
